MerCruiser Emissions Control Engines Equipped with Generation III Cool Fuel Modules

Models Affected

Models Covered	Serial Number Or Year
MCM Bravo Sterndrive MPI EC Engines	0W060000–2A437084
MerCruiser Inboard MPI EC Engines	0M398372–2A437084
MerCruiser EC Ski Engines	1A090000–2A437084
MerCruiser 350 Scorpion EC Engines	0W698433–2A437084
MerCruiser 377 Scorpion EC Engines	1A091488–2A437084

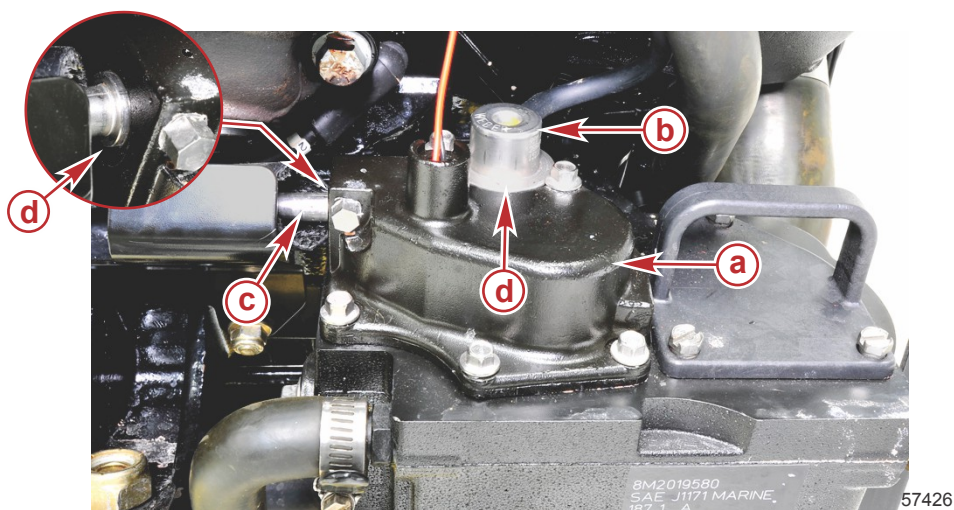
Paint delamination below the fuel pressure regulator on some Generation III Cool Fuel module top covers may cause performance issues, emissions related faults, or fuel weepage at the fuel pressure regulator or fuel module discharge line.

If you encounter fuel weepage, thoroughly inspect the areas around the fuel pressure regulator, discharge fuel line, and below the Gen III Cool Fuel module for the accumulation of fuel residue that would indicate the condition as described.

Replace the Gen III Cool Fuel module top cover, top cover seal, fuel pressure regulator, and the discharge fuel line quad ring if signs of fuel weepage, or paint delamination are observed at the inspection points described in this bulletin.

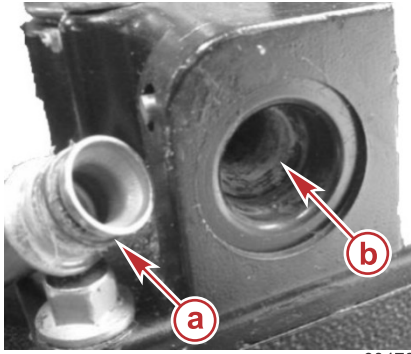
- Remove the discharge fuel line. Inspect the quad ring and the condition of the fuel line bore for missing paint.

IMPORTANT: Do not reuse discharge fuel line quad ring. The quad ring must be replaced prior to discharge fuel line installation.
