Diagnostic Supplement for MerCruiser Engines with Emission Control Technology (ECT)

NOTICE
Revised January 2014. This bulletin supersedes the previous bulletin number 2011-11R1 November 2011.

Models Covered
All sterndrive and inboard engines with emissions control technology (ECT)

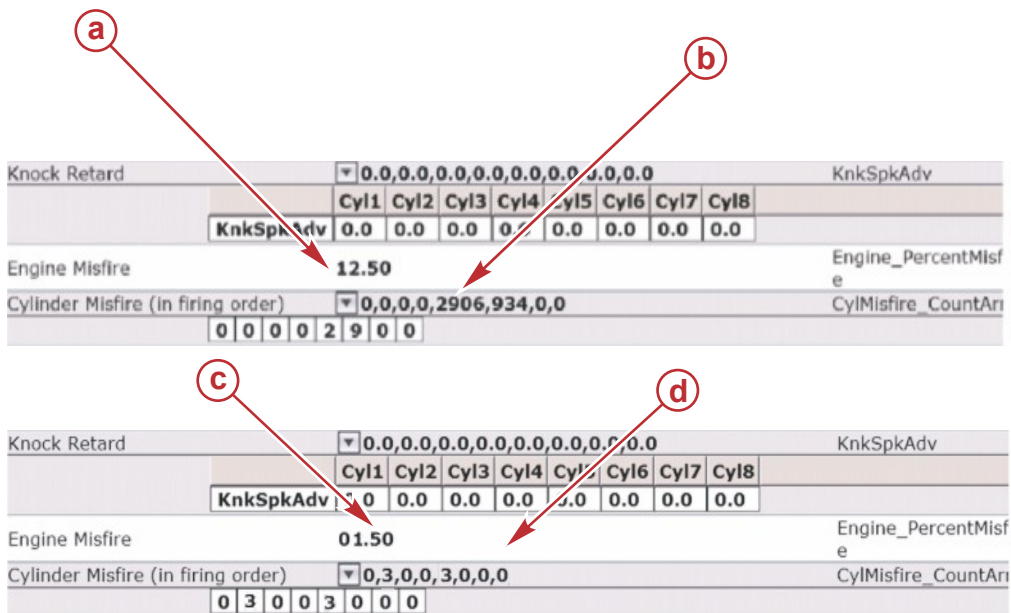
54766

- a - Engine misfire percentage before
- b - Cylinder misfire before
- c - Engine misfire percentage after
- d - Cylinder misfire after

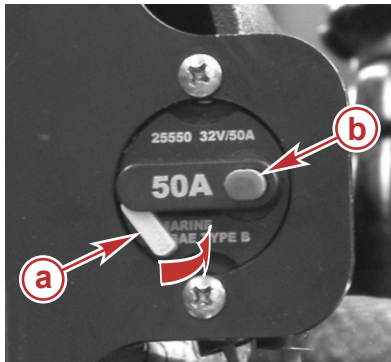
54122

Since 2002, some engines were manufactured with a yellow-flag-type circuit breaker. The 50-amp circuit breaker is the main voltage supply (through the main power relay) for the engine fuse block, which supplies voltage to the fuel injectors, coil and coil driver, PCM drivers, all 5-volt and 12-volt sensors, and O2 sensor heaters.

Yellow flag type 50-amp circuit breaker

If temporarily bypassing the circuit breaker resolves the fault, replace the circuit breaker with a push-button type.

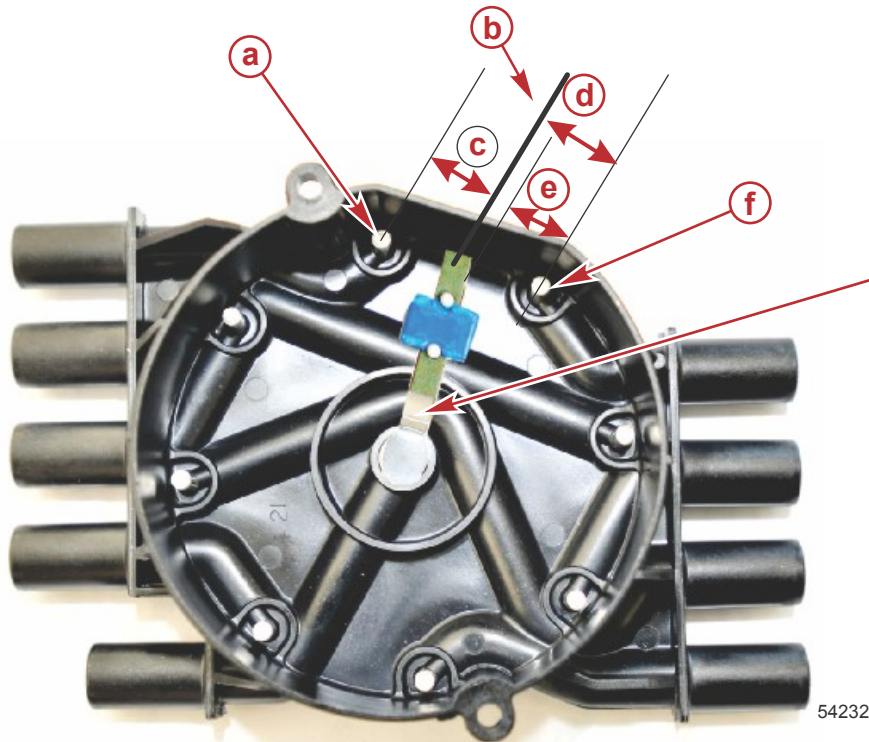
Distributor/HVS rotor positions before adjustment

After 30–100 engine hours, the tolerance between the distributor (high-voltage switch) and the drive components may increase. As the timing chain, timing gears, distributor shaft drive gear and cam gear all wear in, the rotor shaft may become slightly out of phase with the distributor housing, which can result in misfire under load.

- a** - Tower for cylinder just fired
- b** - Midpoint between two cylinder towers. Also the position of the rotor at maximum spark advance.
- c** - Space between rotor and cylinder just fired at maximum spark advance
- d** - Space between rotor and cylinder fired at 30° before TDC (maximum spark advance)
- e** - Approximately 24° before TDC
- f** - Tower of cylinder to be fired
- g** - Rotor
