Diagnostic Supplement for MerCruiser Engines with Emission Control Technology (ECT)

NOTICE
Revised January 2014. This bulletin supersedes the previous bulletin number 2011-11R1 November 2011.

Models Covered
All sterndrive and inboard engines with emissions control technology (ECT)

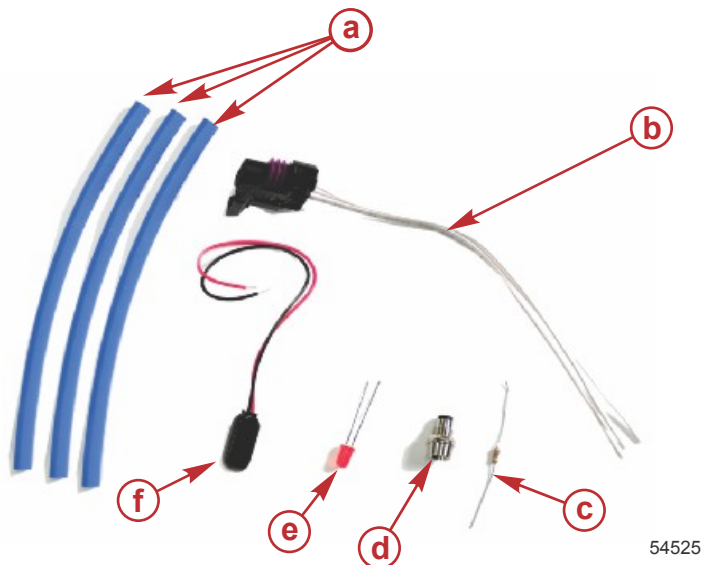
Position indicator light components

- a- Heat shrink tubing (obtain locally) (three 3 in. lengths)
- b- Camshaft position sensor connector (from P/N 879346A34)
- c- 470 ohm ¼ watt resistor (obtain locally)
- d- LED holder (obtain locally)
- e- 5mm LED (obtain locally)
- f- 9-volt battery connector (obtain locally)

Also required: 9-volt battery (obtain locally)

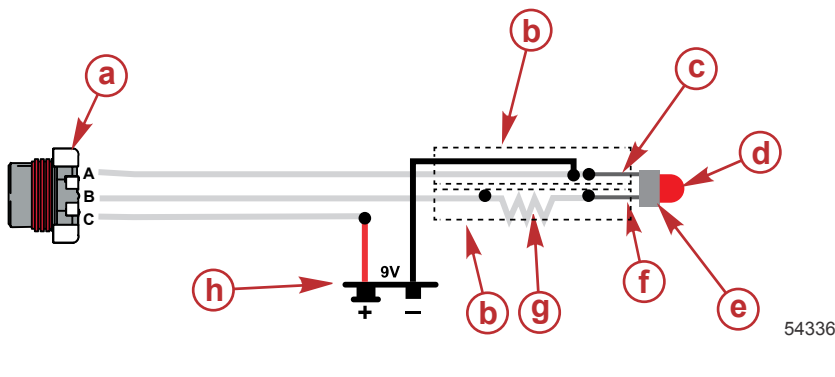
Position indicator light schematic

- a- Camshaft position sensor connector (from P/N 879346A34)
- b- Heat shrink tubing
- c- Cathode (-) (short lead) of light emitting diode (LED)
- d- LED
- e- LED holder
- f- Anode (+) (long lead) of LED
- g- 470 ohm ¼ watt resistor
- h- 9-volt battery connector

IMPORTANT: Crimping, not soldering, the connections is recommended to ensure solid connections and to reduce the possibility of damaging the LED.

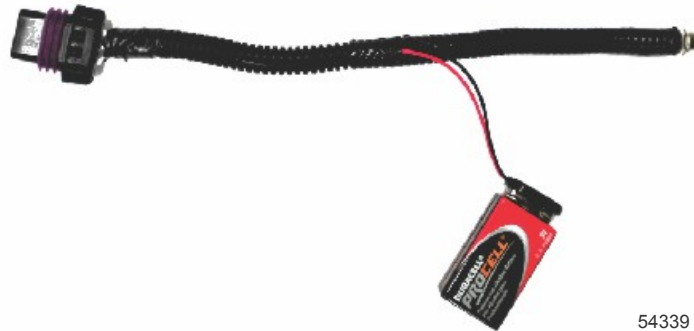
54339

Finished position indicator light shown with optional conduit covering

- When the position indicator light works, apply heat to the heat shrink tubing.

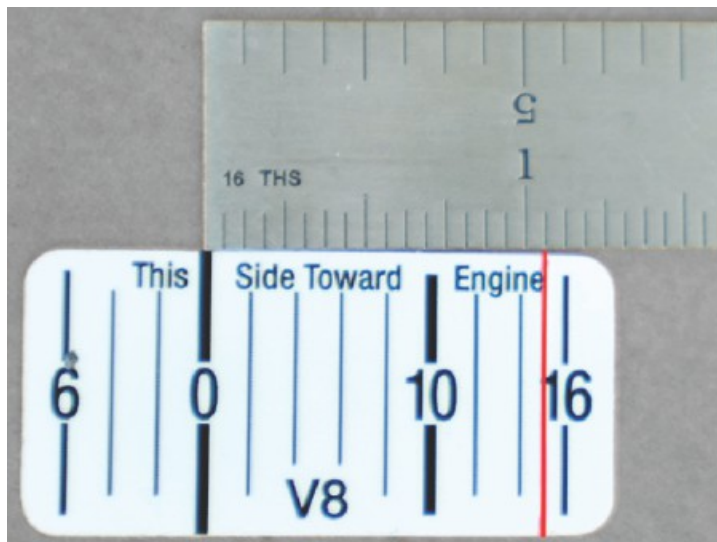
54504

Add a mark 1-1/16 in. to the right of the 0° mark (not shown to scale)

- Disable the ignition system by turning the key to the off position, removing the key from the switch, and turning the lanyard safety switch to the off position.
- Locate a timing mark 1-1/16 in. from 0° using a decal (Mercury part number 8M0079626) or the included template.
 - Due to the possibility that this document was scaled up or down by your printer, confirm that the highlighted mark on the timing decal (refer to **Timing Decal**) is 1-1/16 in. to the right of the 0° mark.

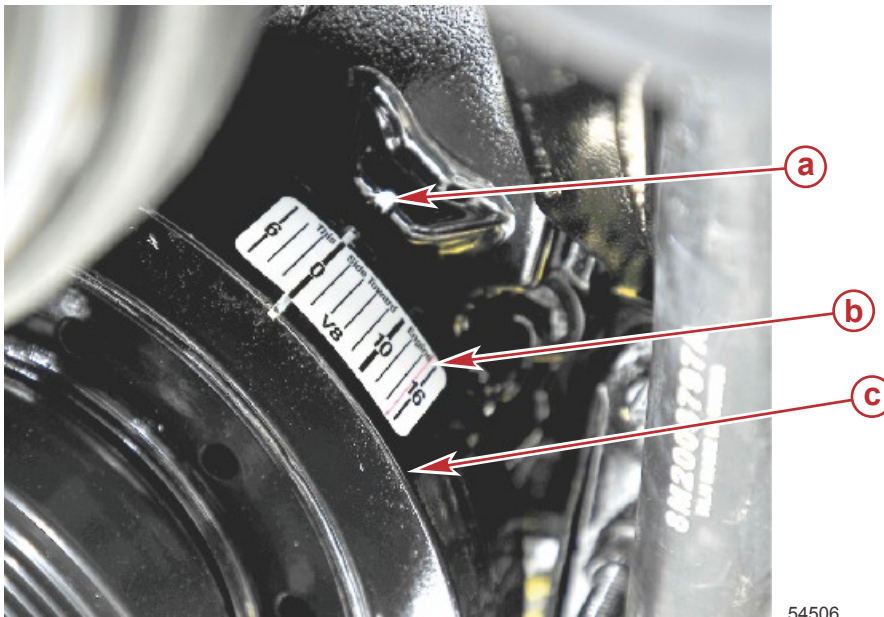
54506

- a - Index mark
- b - Timing template with 1-1/16 in. mark highlighted
- c - Harmonic balancer

5. Attach the timing template or decal to the harmonic balancer, ensuring that the 0° marks on both the balancer and decal align.

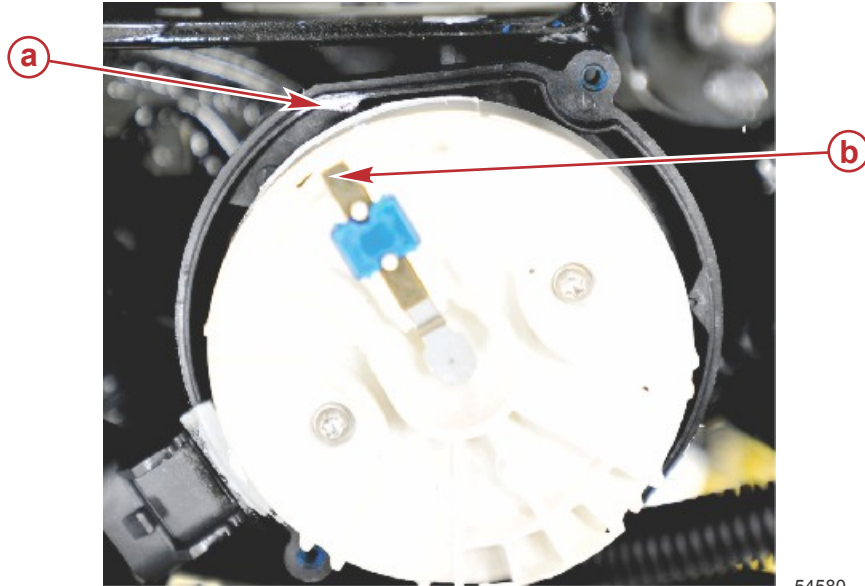
- a - "8" marking on distributor housing
- b - Rotor

- b. Using a remote starter switch, crank the engine until the index mark on the harmonic balancer is at the 15° mark and the rotor is near the "8" marking on the distributor housing. It may be necessary to use a remote switch to get close to the position, and then use a breaker bar and socket to precisely align the marks. If you overshoot the mark, crank the engine through two revolutions until the rotor is near the "8" marking. Do not back up.

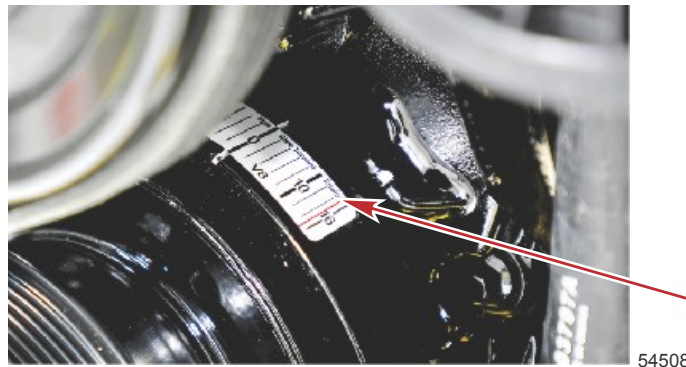
Crankshaft rotated until number 1 cylinder is 15° before top dead center (BTDC)

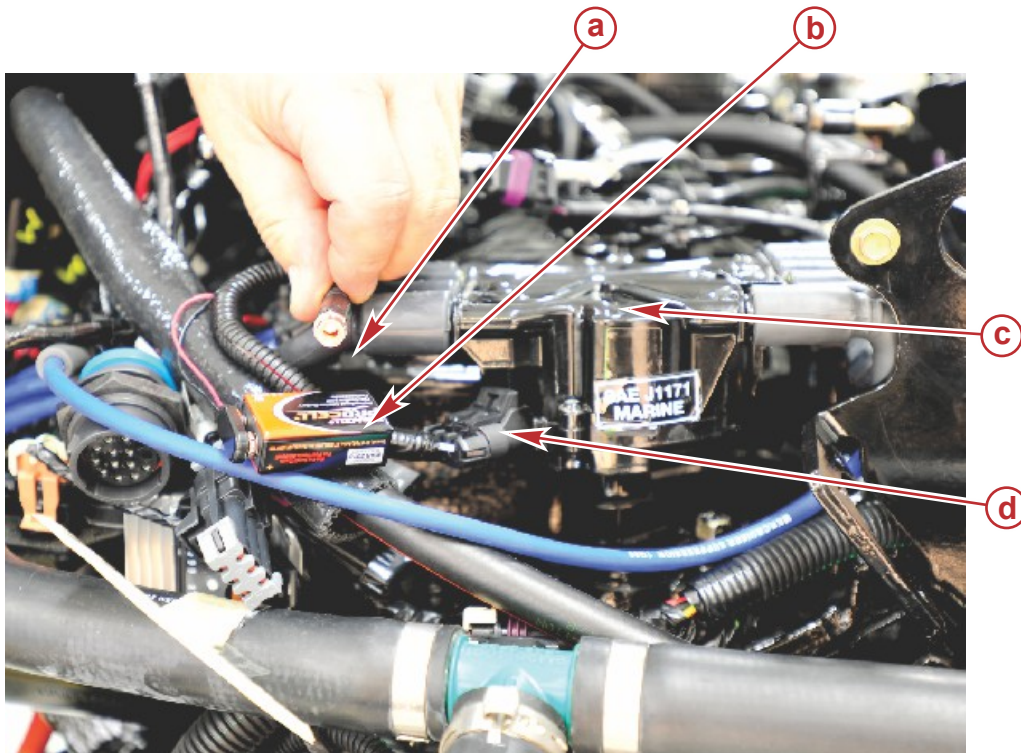
54345

- a** - LED
b - 9-volt battery
c - Distributor/HVS cap
d - Position indicator light plugged into the camshaft sensor connector

11. Rotate the distributor/HVS clockwise until the light comes on; then, rotate it slowly counterclockwise until the light goes out.
